## Issue: Tile Delamination on Pool Water Feature Walls

July 2026

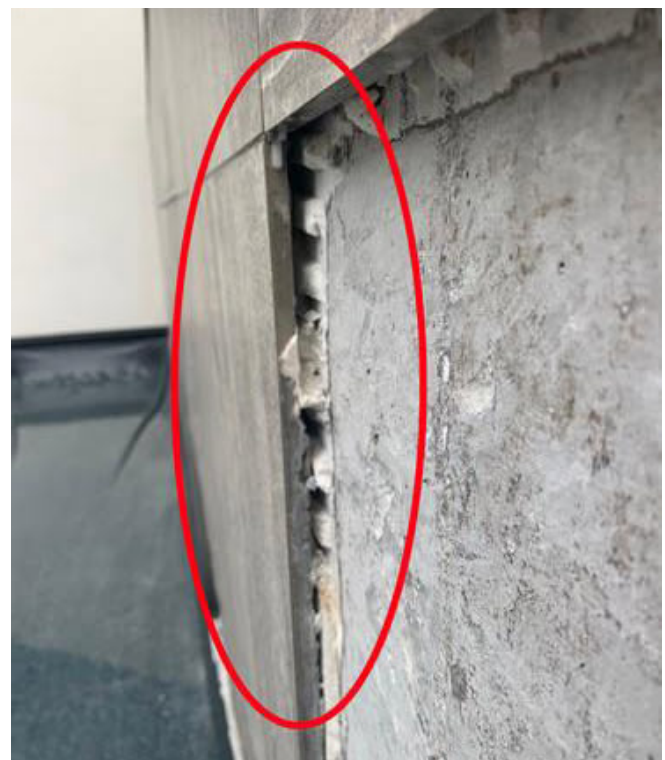
*Pic 2. Tile separation from the substrate is visible.*

In this instance, the original waterproofing membrane installed behind the tiled water feature wall appears to have been unsuitable for a chlorinated pool environment. Over time, exposure to chlorinated pool water has likely degraded the membrane system, resulting in loss of bond and subsequent tile failure.

- **Remove Affected Tiles.** Remove all loose, drummy, and affected tiles within the water feature area. The full extent of delamination should be assessed before repairs begin, as failure may extend beyond visibly loose tiles.

- **Prepare and Repair the Substrate.** The substrate must be sound, clean, dry where required by the selected system, and free from laitance, dirt, old membrane, glue, adhesive residue, and other contaminants. Any damaged or uneven areas should be repaired using a suitable concrete repair mortar before re-waterproofing.

- **Install a Suitable Waterproofing System.** A waterproofing system designed for continuous immersion and chlorinated pool environments must be used. Suitable options may include:

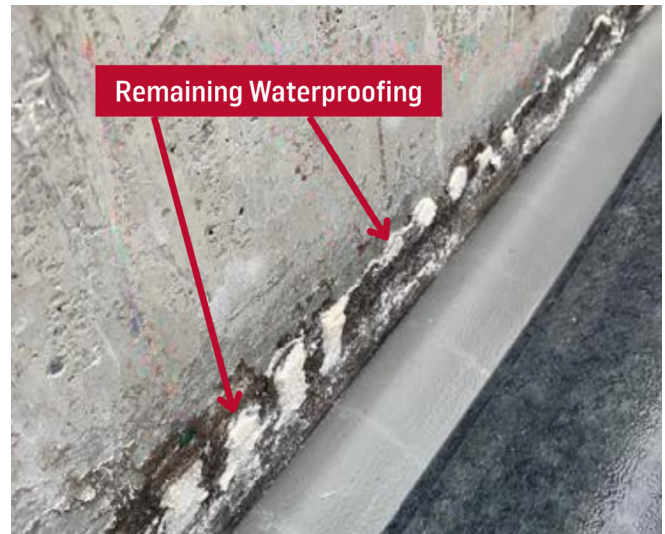
Pic 3. Remaining waterproofing and adhesive residue can be seen on the exposed substrate.

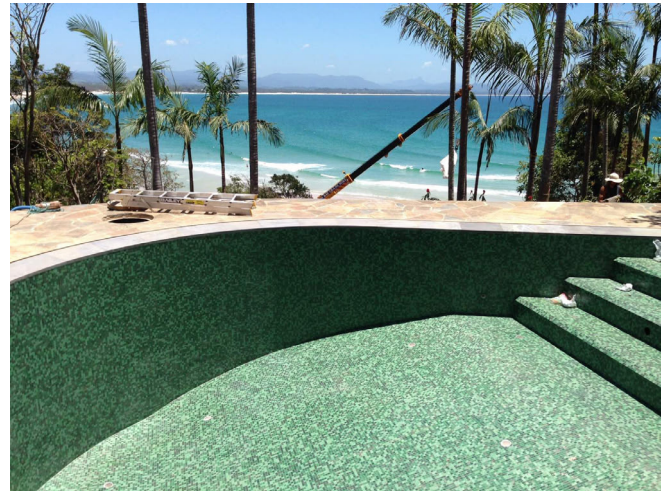
*Pic 6. A good example of pool waterproofing using the LATICRETE Pool System.*

- LATICRETE Pool System.
  - WPA 560 applied in two coats with WPA 200 and TPA Lite, where suitable for the application and installed in accordance with manufacturer requirements.
