PROJECT REFERENCE

CONCRETE REPAIR

Alexandra Headlands Water Tower

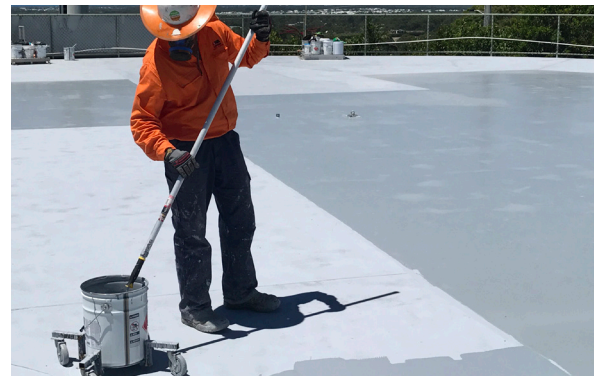
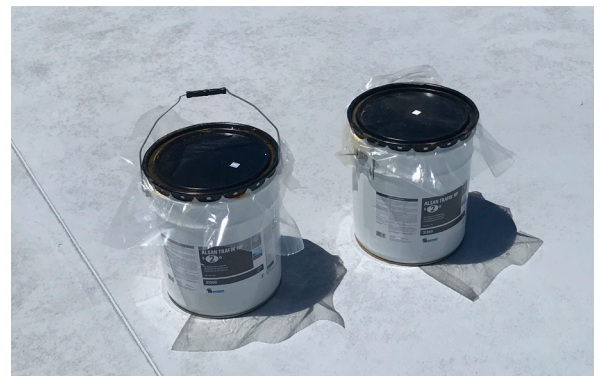
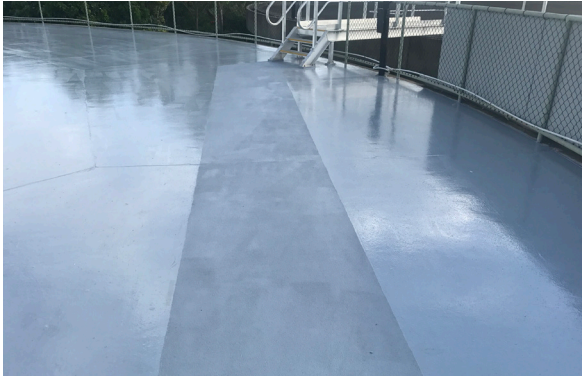
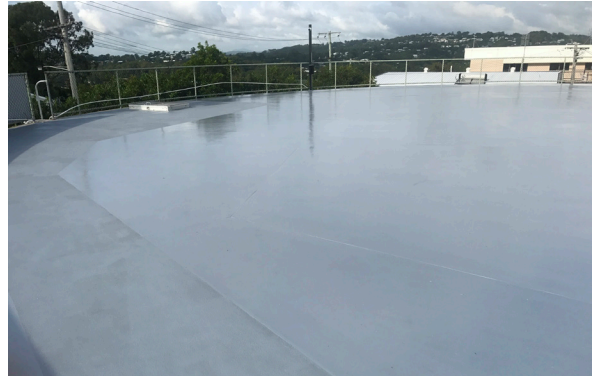
The client had an old degraded membrane on the water tanks that had failed. A trafficable polyurethane membrane system from Soprema was put forward and approved by the client. The existing membrane was removed by mechanical means back to clean concrete. Cracks in the concrete were cleaned out and filled with a flexible fast cure polyurethane sealant. The Soprema Alsan Trafik System was then installed using a 5 coat application. The result of this was a seamless, UV stable, flexible, tough waterproof membrane system that the client was pleased with.
