## LEAKING PLANT ROOM

**Date:** October 2020  
**Project:** Leaking Plant Room  
**Client:** Building Manager, Phillip St Sydney  
**Applicator:** Optimo Waterproofing  
**Application:** Soprema ALSAN® Trafik System

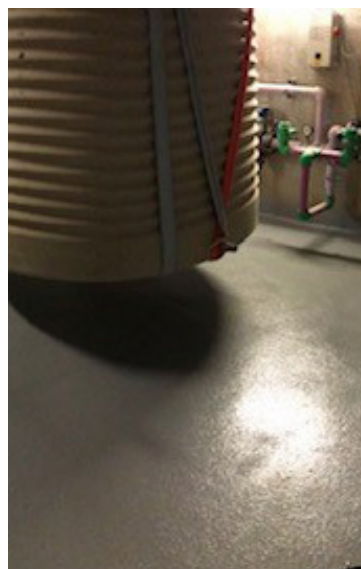
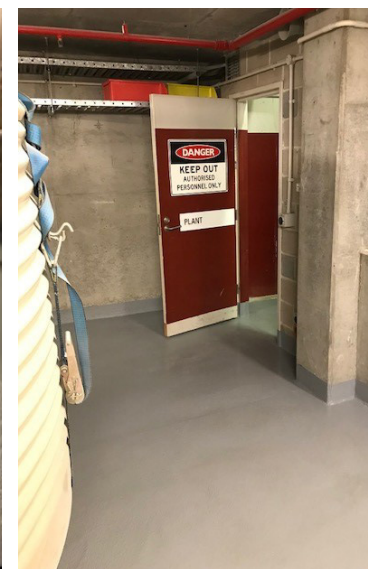
This high-rise plant room is on the ground floor and was leaking via overflow pipes into the carpark/basement below due to poor design. The solution involved emptying the water tank and suspending it from the ceiling to allow access for the remedial preparation of the plant room floor and application of the Soprema ALSAN® Trafik System.

- Soprema ALSAN® EP100 H2O Primer
- Soprema ALSAN® Trafik 520
- Soprema ALSAN® Trafik 530 (Sand Seeded)
