CASE STUDY

ALEXANDRA HEADLANDS WATER TOWER ALEXANDRIA HEADLANDS

Date:	March 2018
Project:	Remedial
Builder:	Unity Water
Applicator:	Simon Groth Accurate Waterproofing
Applicaton:	Concrete Repair

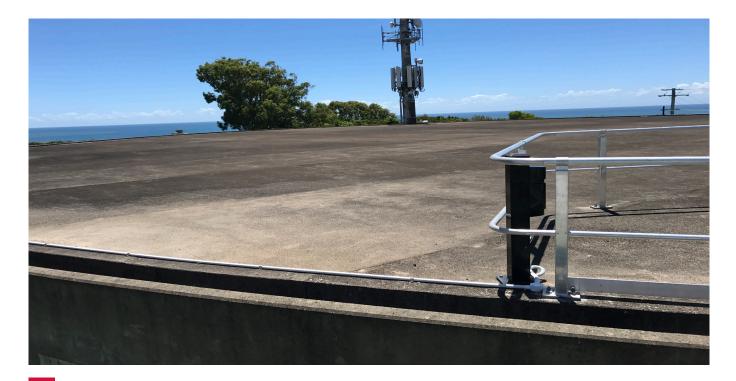
SOPREMA Alsan Trafik HP 510 SOPREMA Alsan Trafik HP 520 SOPREMA Alsan Trafik HP 530 SOPREMA Alsan Trafik HP 540 The client had an old degraded membrane on the water tanks that had failed. A trafficable polyurethane membrane system from SOPREMA was put forward and approved by the client.

The existing membrane was removed by mechanical means back to clean concrete. Cracks in the concrete were cleaned out and filled with a flexible fast cure polyurethane sealant.

The SOPREMA Alsan Trafik System was then installed using a 5 coat application. The result of this was a seamless, UV stable, flexible, tough waterproof membrane system that the client was pleased with.
